Case study: Enclosed Gardens of Mechelen

Author(s) of the report: Victoria Beltran, Andrea Marchetti, Karolien De Wael (UA)

Report date: 19/11/2021

Research keyword(s): Alloys, Brass, Copper, Degradation

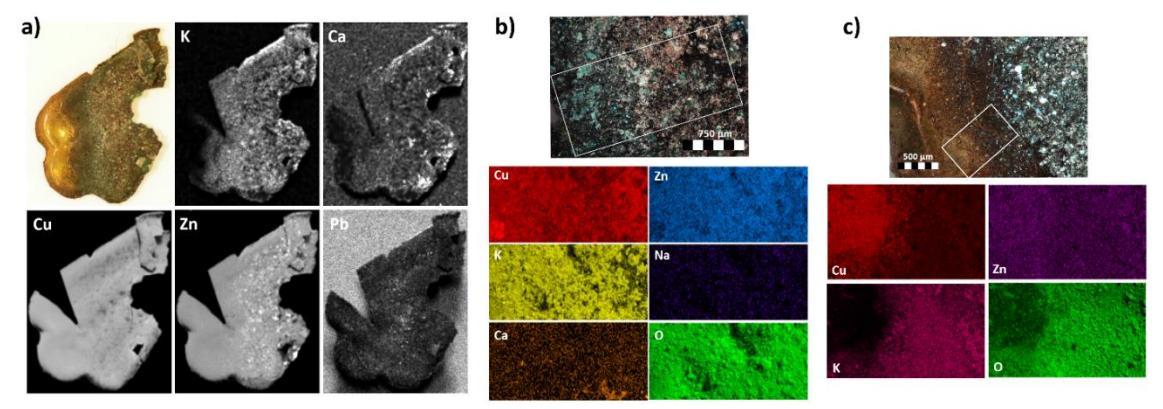
Fig. 1. Elemental analysis of the corroded sequin (sample 1S): a) MA-XRF elemental maps; b), c) SEM-EDX elemental maps.

These results support the hypothesis of a direct chemical interaction between the glass and the metal objects. In particular, the systematic presence of K, often mixed with Zn (Fig. 1 and Fig. 2), on the surface of the corroded brass elements, is likely a result of a glass-induced corrosion process of the metal.(1) Alkaline cations such as K⁺ (and Na⁺), can in fact leach out from the silica network during the degradation of glass and then reprecipitate, possibly in the form of mixed salts when in contact with a corroding metal(1–3). Zn and K mixed salts (possibly carboxylates), have been recently described by Fischer et al.(4) as products of a glass-induced metal corrosion on the surface of historical brass objects.

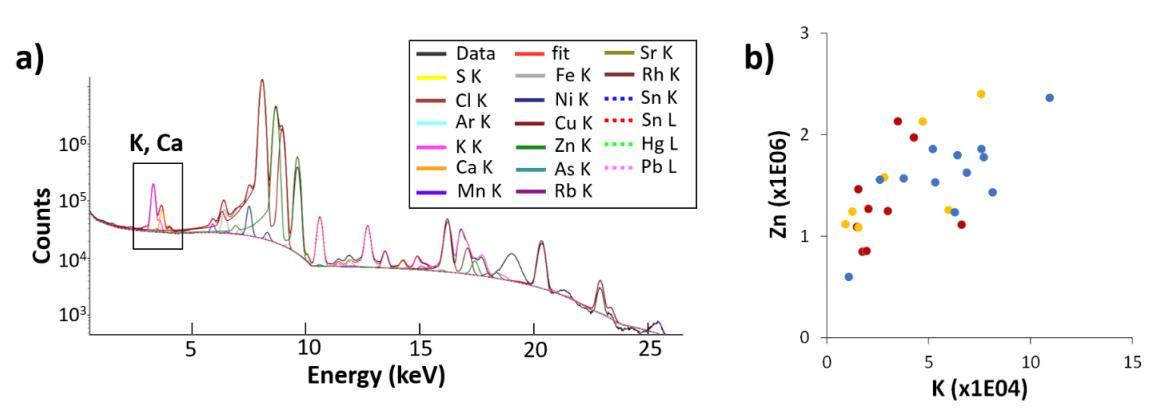
Fig. 2. µXRF analysis of the visually degraded areas of the corroded brass wires analyzed: a) SUM spectrum, in evidence the presence of K and Ca; b) elemental scatter plot for Zn and K (integrated K Lines; red = sample 1W, yellow= sample 2W, blue = sample 3W).

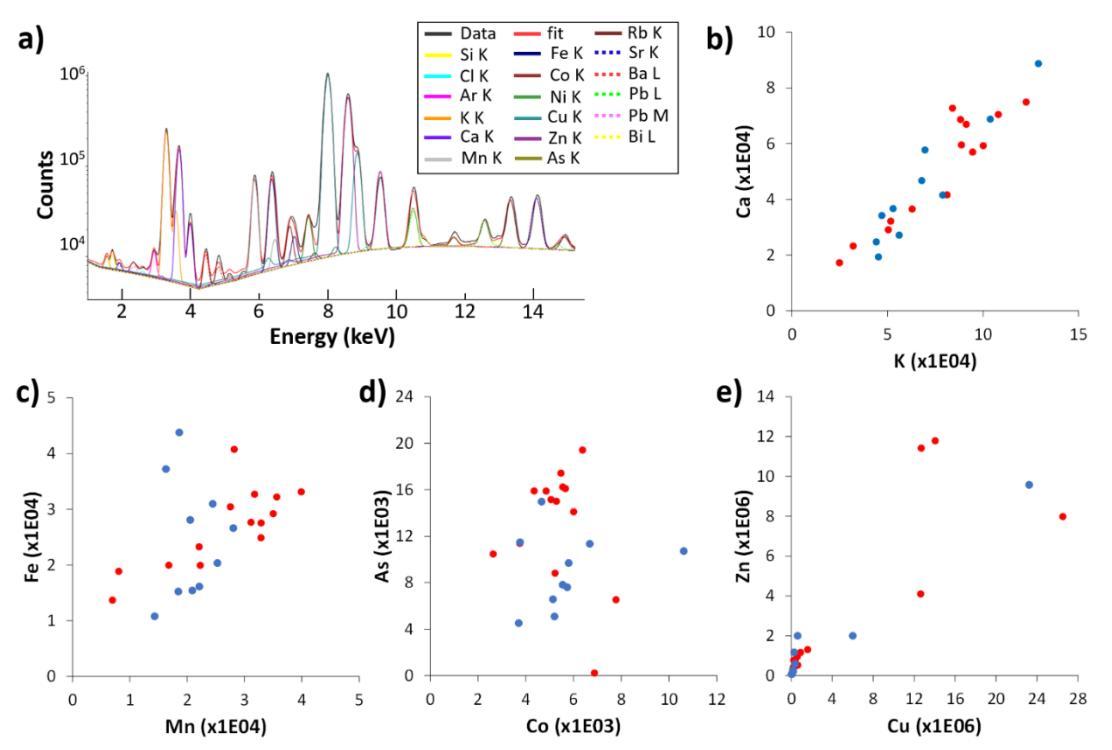
Fig. 3. μ XRF analysis of different areas of the glass beads: a) SUM spectrum; b), c), d) elemental scatter plots (red = sample 1B; blue = sample 2B). The points showing higher levels of Cu and Zn correspond to areas with green-blue corrosion products.

The hypothesis of K^{+} originating from the glass beads is clearly supported by the chemical composition of the glass, since both glass beads are made of a potash rich glass (Fig. 3), and by the poor conservation state of the beads.

In a similar fashion, the enrichment of Cu and Zn in the corrosion products on the surface of the weathered glass beads (Fig. 3), and in particular in areas where the contact with the metal would have been more probable (on the central shaft and inner rim, Fig. 4), also supports the hypothesis of an interaction between brass and glass.

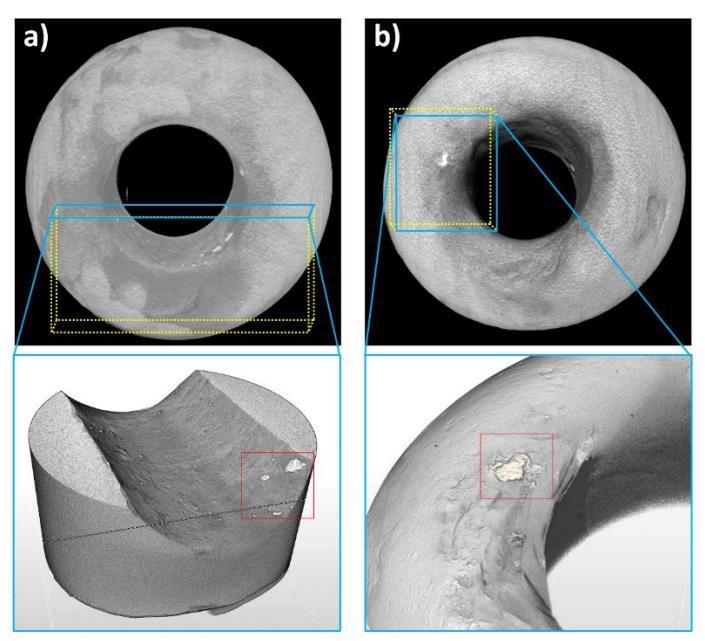
Fig. 4. µCT scan results: reconstructed volume and localization of highly attenuating corrosion products (red rectangles) on the inner rim and central shaft of the two glass beads a) sample 2B, b) sample 1B.

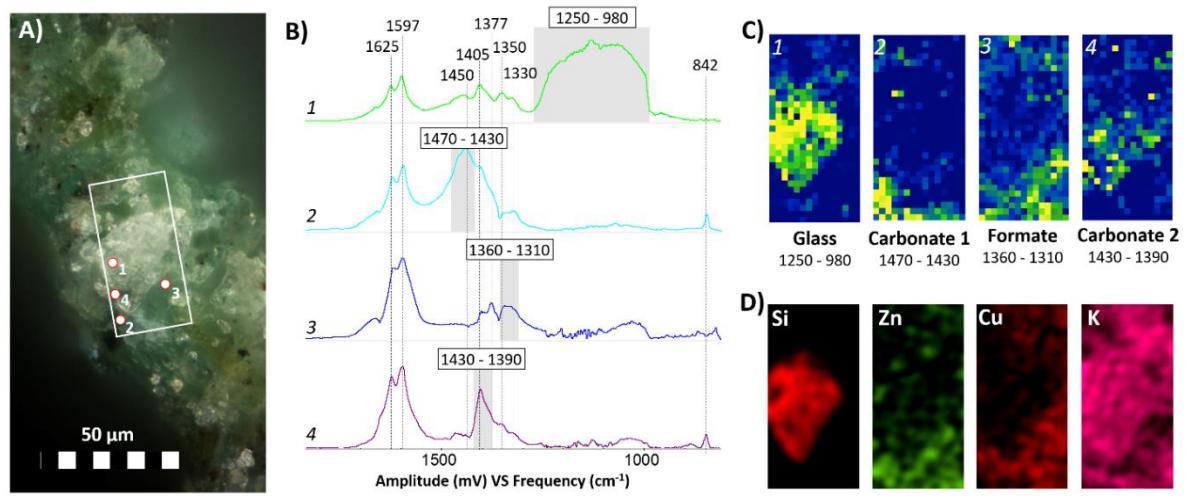
Fig. 5. High-resolution O-PTIR molecular imaging of degradation products on the surface of the degraded brass sequin (1S). A) OM photomicrograph of the area in analysis, in evidence the location of the representative spectra shown in B (numbered points) and of the imaged area (white rectangle); B) representative spectra of the imaged species and integration range (in grey); C) corresponding integration maps (30x62 µm with a pixel size of 2 µm) with tentative interpretation (integration range in cm⁻¹); D) complementary SEM-EDX elemental imaging of the scanned area.

Indeed, in figures 5-7, an overview of the results of O-PTIR and complementary analyses on three different samples (representative of the three categories of objects considered: metal sequin, metal wires, glass beads) are presented. In particular, Fig. 5 shows the analysis of a small area ($30x62 \mu m$) on the surface of the corroded sequin, while Fig. 6 and Fig. 7 contain the results of point analyses on the surface of a glass bead and a corroded wire respectively.

the molecular signature of glass is clearly identified in a particle on the surface of the metal sequin (Fig. 5B spectrum 1 and Fig. 5C) due to the very broad and intense (slightly saturated) band between 1250 and 980 cm⁻¹ (Si-O-Si and Si-O region(7)). A very similar spectrum is observed in a visually nondegraded area on the surface of a potash glass bead (Fig. 6A spectrum 1), which supports the hypothesis of a direct contact between the brass object and this type of glass. The chemical information obtained with O-PTIR goes beyond but clearly agrees with the complementary SEM-EDX elemental analysis (Fig. 5D and Fig. 5B), showing higher Si and K contents in the areas identified as glass. The additional bands in the 1650–1300 cm⁻¹ region hints to the presence of other species (e.g. spectra 2, 3 and 4 in Fig. 5B) overlapping and in close contact with the glass particle. It is noticeable that similar spectral features can be observed in this region on the surface of the glass beads (Fig. 6A spectrum 1), indicating that the related compounds might be associated to the degradation of glass. In particular, the spectrum agrees with the presence of carboxylate (formate and/or acetate) species (bands at ≈1600-1500 and ≈1500-1400 cm⁻¹ related to C-O asymmetric and symmetric stretching respectively) as well as with the presence of carbonates (bands at ≈1450-1350 cm⁻¹ related to C-O stretching). (8) These compounds have been previously linked to the degradation of glass (9). In addition, the bands at \approx 1625 and \approx 1320 cm⁻¹ may be linked to the presence of oxalates, which are usually found linked to different types of degradation processes on cultural heritage materials.(10) Interestingly, the spectral features of oxalates appear in all spectra in Figure 5, suggesting a presence of these corrosion products in all points analyzed. The results demonstrate that the mentioned compounds may coexist in the same region.

Spectrum 2 of Fig. 5B is one of the spectra most commonly encountered in the green-bluish areas of the sequin, glass beads and wires alike (Fig. 6A spectrum 2, Fig. 7A spectrum 2). This compound is more abundant in areas containing Cu and O and close to no Zn and K (Fig. 5C,D). The intense peaks in the 1650–1580 cm⁻¹ and 1400–1320 cm⁻¹ regions indicate the presence of a carboxylate and, in particular, of a Cu formate(11).

Basic copper formates are extremely rare as corrosion products on historical metal objects, unless the degradation is catalyzed by the contact with weathered glass(1). The alkaline liquid film formed during the degradation of glass, in fact, favors both the solubilization of the metal alloy and the conversion of formaldehyde (off-gassed during the ageing of wood and other organic materials(12)) to formic acid through the Cannizzaro reaction(4), ultimately leading to the precipitation of the basic form of the metal formate. In the context of this study, the diffuse presence of basic copper formate on all the samples in analysis (the spectral markers of this compound are visible in all spectra from figure 5, 6 and 7) decisively confirms the existence of a chemical interaction between weathered glass and brass. The strong connection between this formate corrosion product and glass is further supported by the close contact observed between these two materials in Fig. 5C, visualized thanks to the high spatial resolution allowed by the O-PTIR analysis.

Spectrum 3 in Fig. 5B is tentatively assigned to a carbonate species, in particular the band at \approx 1400 cm⁻¹ is likely related to the stretching and the one at \approx 842 cm⁻¹ to the bending of the CO₃²⁻ group(13). Given the overlap of the bands with the signal from other species, the identification of the precise type of carbonate cannot be done unambiguously only by OPTIR. Based on the SEM-EDX results (Fig. 5D), this could correspond to a type of potassium carbonate resulting from the degradation of the potash glass(14).

Spectrum 4 in Fig. 5B is characterized by an intense and broad absorption at around 1440 cm⁻¹. The explanation for the broad and complex nature of the band can be found in the overlapping of the signals from several species, such as the ones in spectrum 2 and spectrum 3 of Fig. 5B, with additional metal carbonates and/or a mixed metal carbonates.(13) The co-presence of different species is in agreement with the overlapping of Zn, K and Cu signals observed in these areas with SEM-EDX (Fig. 5D).

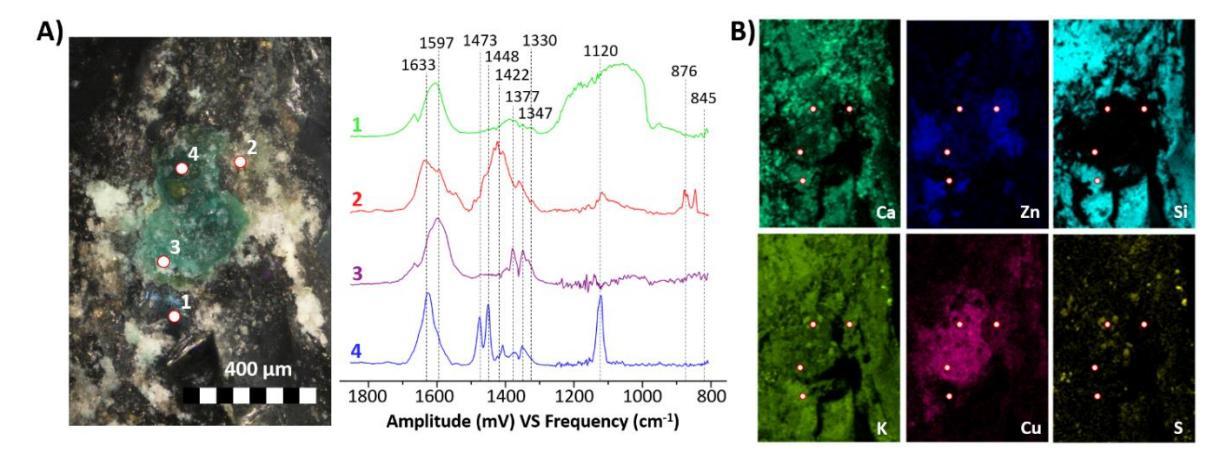
Fig. 6. O-PTIR point analysis of degradation products on the surface of a glass bead (sample 1B). A) Locations analyzed (OM photomicrograph) and corresponding spectra; B) complementary SEM-EDX elemental imaging of the region of interest.

IR spectra with similar bands were observed in areas rich in Zn, K and Cu also on a glass bead (Fig. 6A spectrum 3) and on two corroded brass wires (Fig. 7A spectrum 1), although with slightly different features. In particular, a carbonate with a CO_3^{2-} asymmetric stretching vibration at 1422 cm⁻¹ and two bending vibrations at 876 and 845 cm⁻¹ was observed in a white corrosion product on the surface of the glass bead (Fig. 6A spectrum 3), while a carbonate with a CO_3^{2-} asymmetric stretching vibration shifted to 1480 cm⁻¹ and either one bending vibration at 878 cm⁻¹ or two bending vibrations at 880 and 842 cm⁻¹ was observed on two different brass wires (Fig. 7A spectrum 1).

On the surface of the glass bead, an additional species was also observed in an area rich in Ca, K, Cu and S (Fig. 6 spectrum 4). The high S content together with the intense bands at 1120 cm⁻¹ (SO_4^{2-}

stretching) and 1630 cm⁻¹ (OH bending) suggests the presence of sulfates/hydrated sulfates (such as gypsum(15) or syngenite(16)), possibly mixed with a metal (probably Cu, Ca, K or a mixture of these metals) carboxylate (additional peaks at ~1600 cm⁻¹ related to the C-O asymmetric stretching of COO- and 1473 and 1448 cm⁻¹ related to the C-O symmetric stretching of COO⁻ and to C-H vibrations). Sulfates and hydrated sulfates are often encountered as degradation products on the surface of potash-lime glass due to the interaction with atmospheric agents(17), while the presence of metal carboxylates in the degradation products might further support the hypothesis of a glass-induced corrosion of brass (Cu often forms complex mixed carboxylates in these conditions(1)).

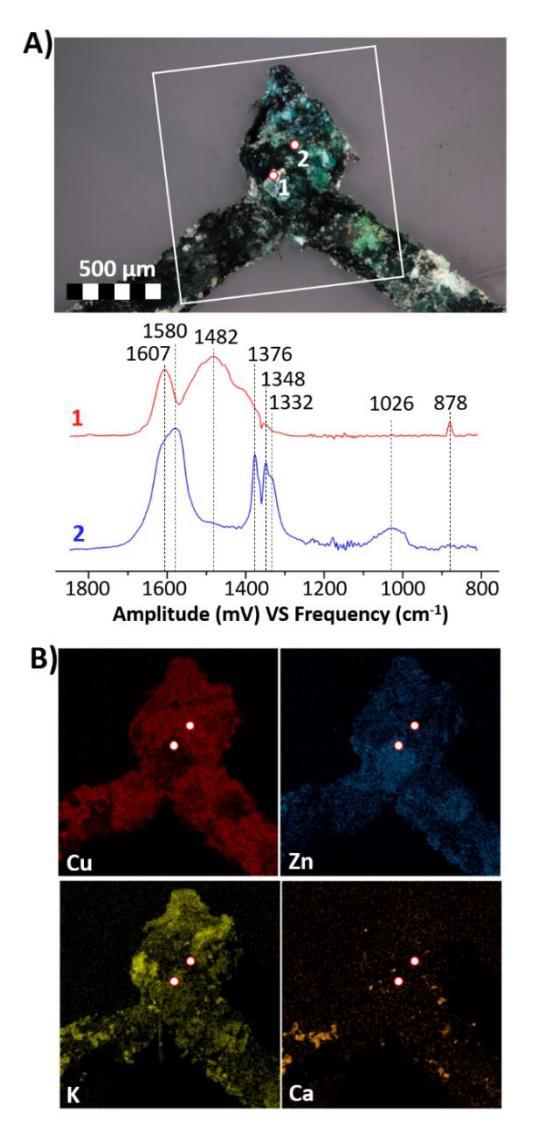
Fig. 7. O-PTIR point analysis of degradation products on the surface of a corroded brass wire (sample 2W). A) Locations analyzed (OM photomicrograph) and corresponding spectra; B) complementary SEM-EDX elemental imaging of the region of interest (white rectangle in Fig. A).
